UNITED STATES ENVIRONMENTAL PROTECTION AGENCY REGION 8

**Subject:** POLREP #1 (Initial Pollution Report) – Removal Assessment  
Gold King Mine Site  
Site #085M  
Silverton, CO  
Latitude: 37.8945 Longitude: -107.6384

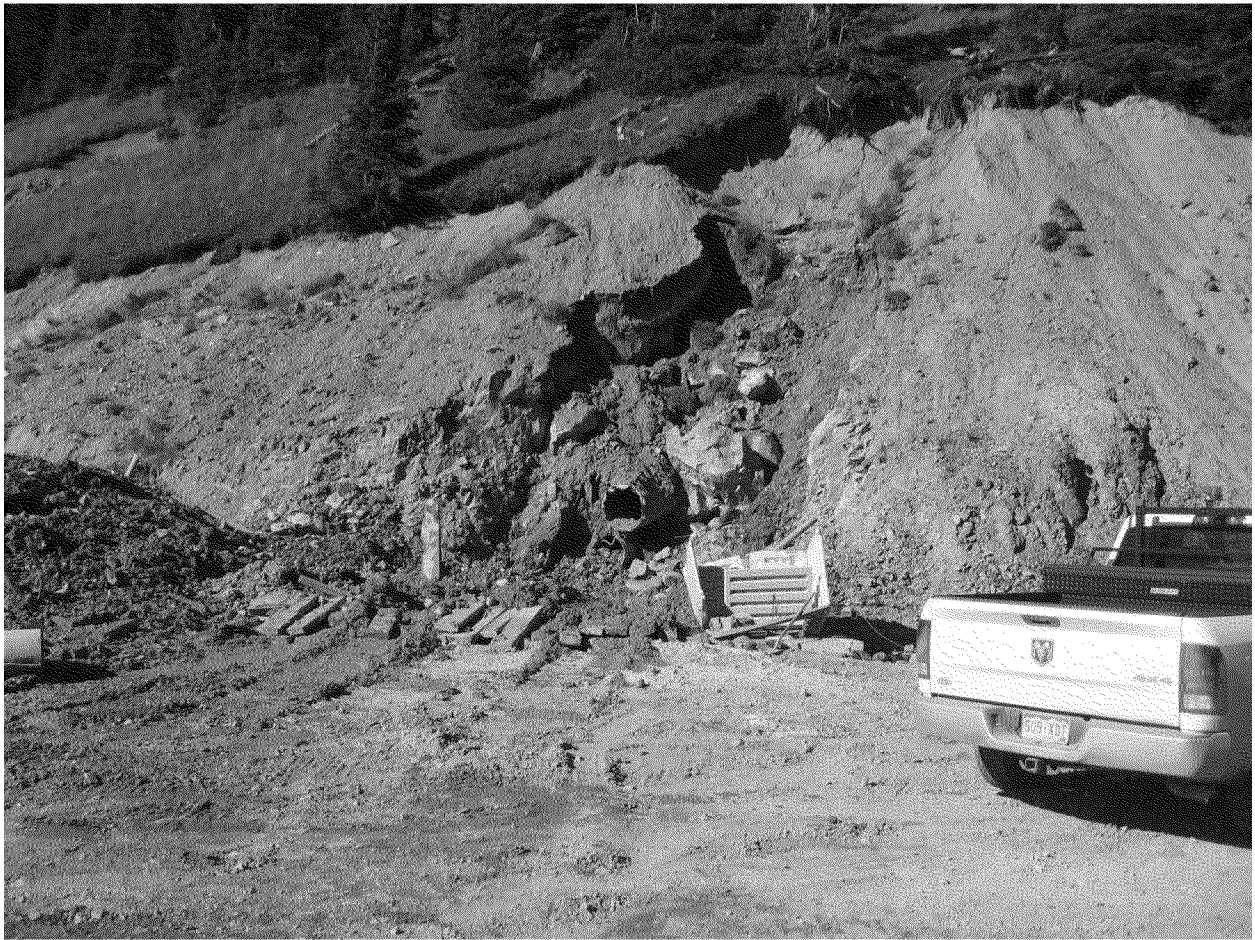
- The condition that was exposed revealed that two 24 inch pipe were in the tunnel blockage adjacent to the top (roof) of the adit. Timbers were observed on the sides and a cap timber was also observed by the contractor. The presence of the 2 – 24 inch pipe indicated the current flow of water was coming out only four feet below the roof, and then there was approximately 6 feet of impounded water below the level of the dump surface. (See Photo below)

Gold King Mine – 9/11/14: collapsed adit pipe near roof of the adit/tunnel.
